(NASA-CR-183585) SPACE STATION PROTECTIVE
COATING DEVELOPMENT Final Report (Boeing
Aerospace Co.) 304 p CSCL 22B

SPACE STATION PROTECTIVE COATING DEVELOPMENT

Final Report

**Contract NAS8-36586
January 1989**

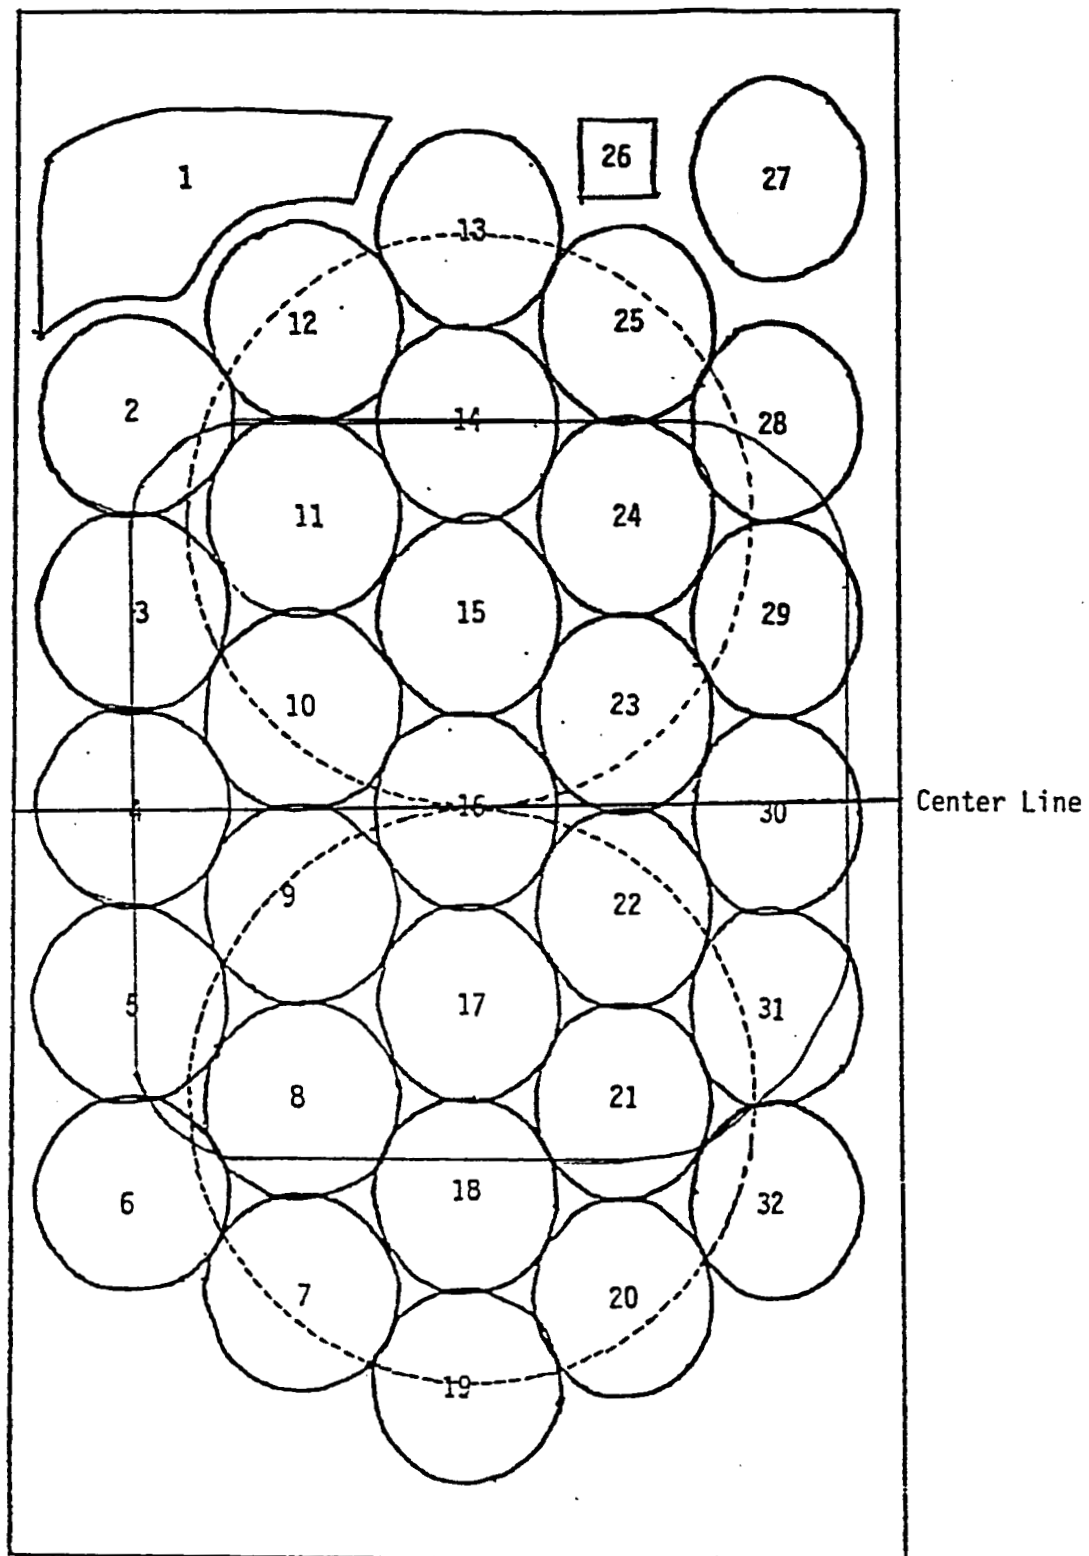
Figure 13: Sample Arrangement During The Latest Combined Effects Test, Showing The Areas Exposed To The Proton And UV Flux _____, And The Areas Exposed To The Vacuum UV Flux -----.

The second set of samples exposed to UV, H+, and e- consisted of 30 specimens and two witness plates. The simulated solar UV reaches all or part of 11 specimens. The proton beam covers the identical areas of those 11 samples plus all or part of 9 additional samples. The electron beam covers a larger area so that some samples receive a dose of electrons only. Figures 13 and 14 show the arrangement of the samples on the test plate and the identify of each sample, respectively. Figure 13 also shows an outline of each area exposed to a particular type of radiation.

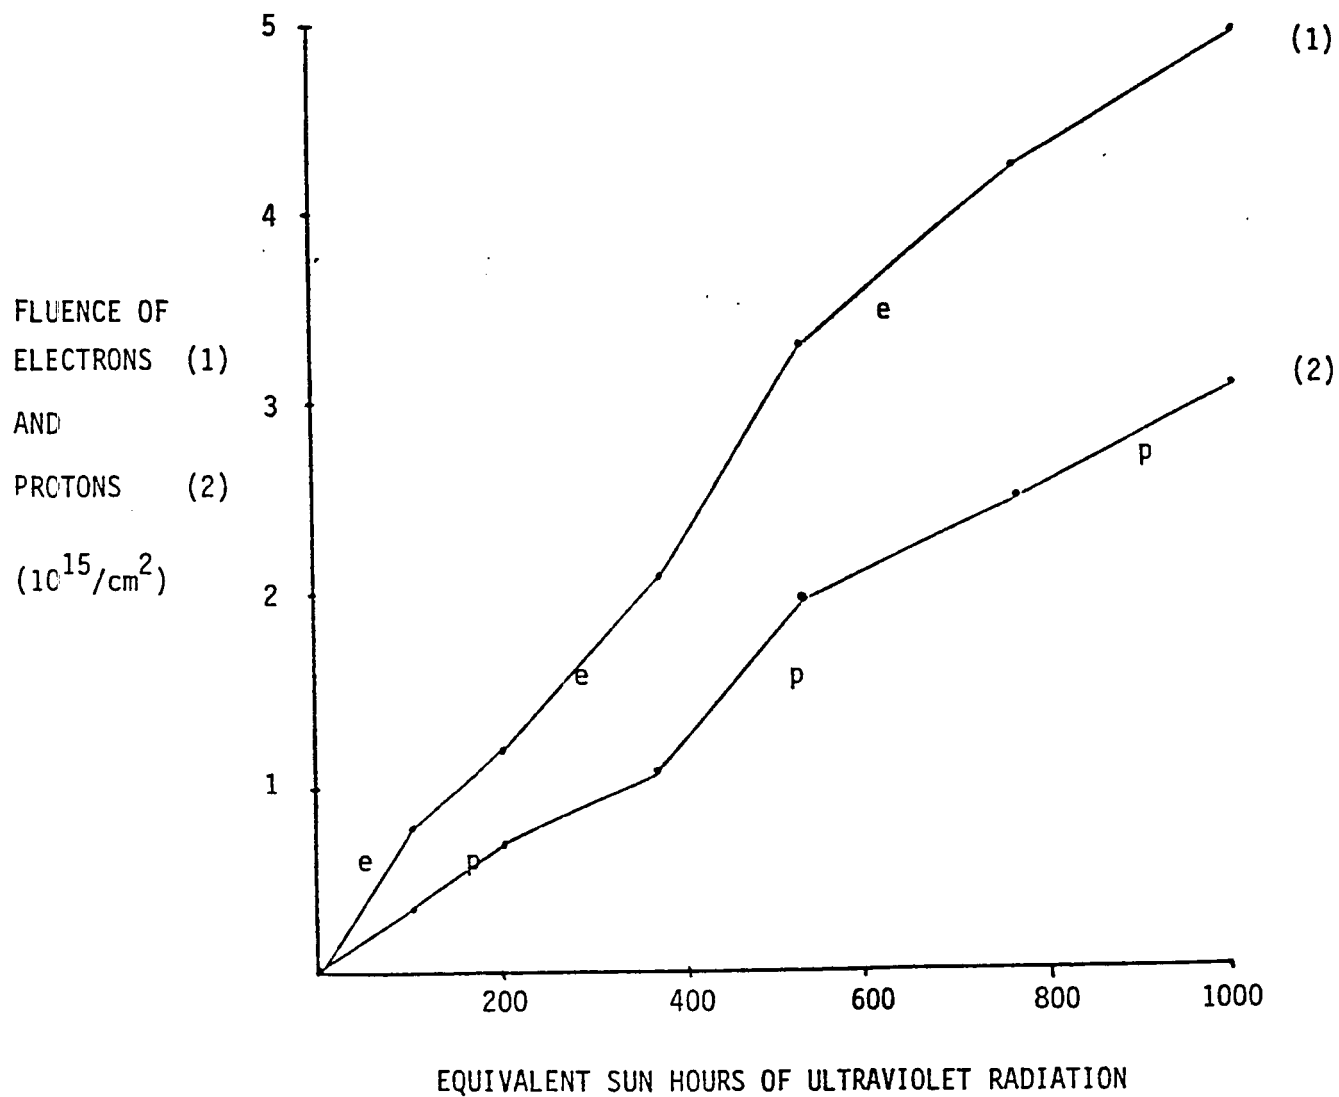
Figure 15: Proton And Electron Fluence As A Function Of UV Radiation Dose

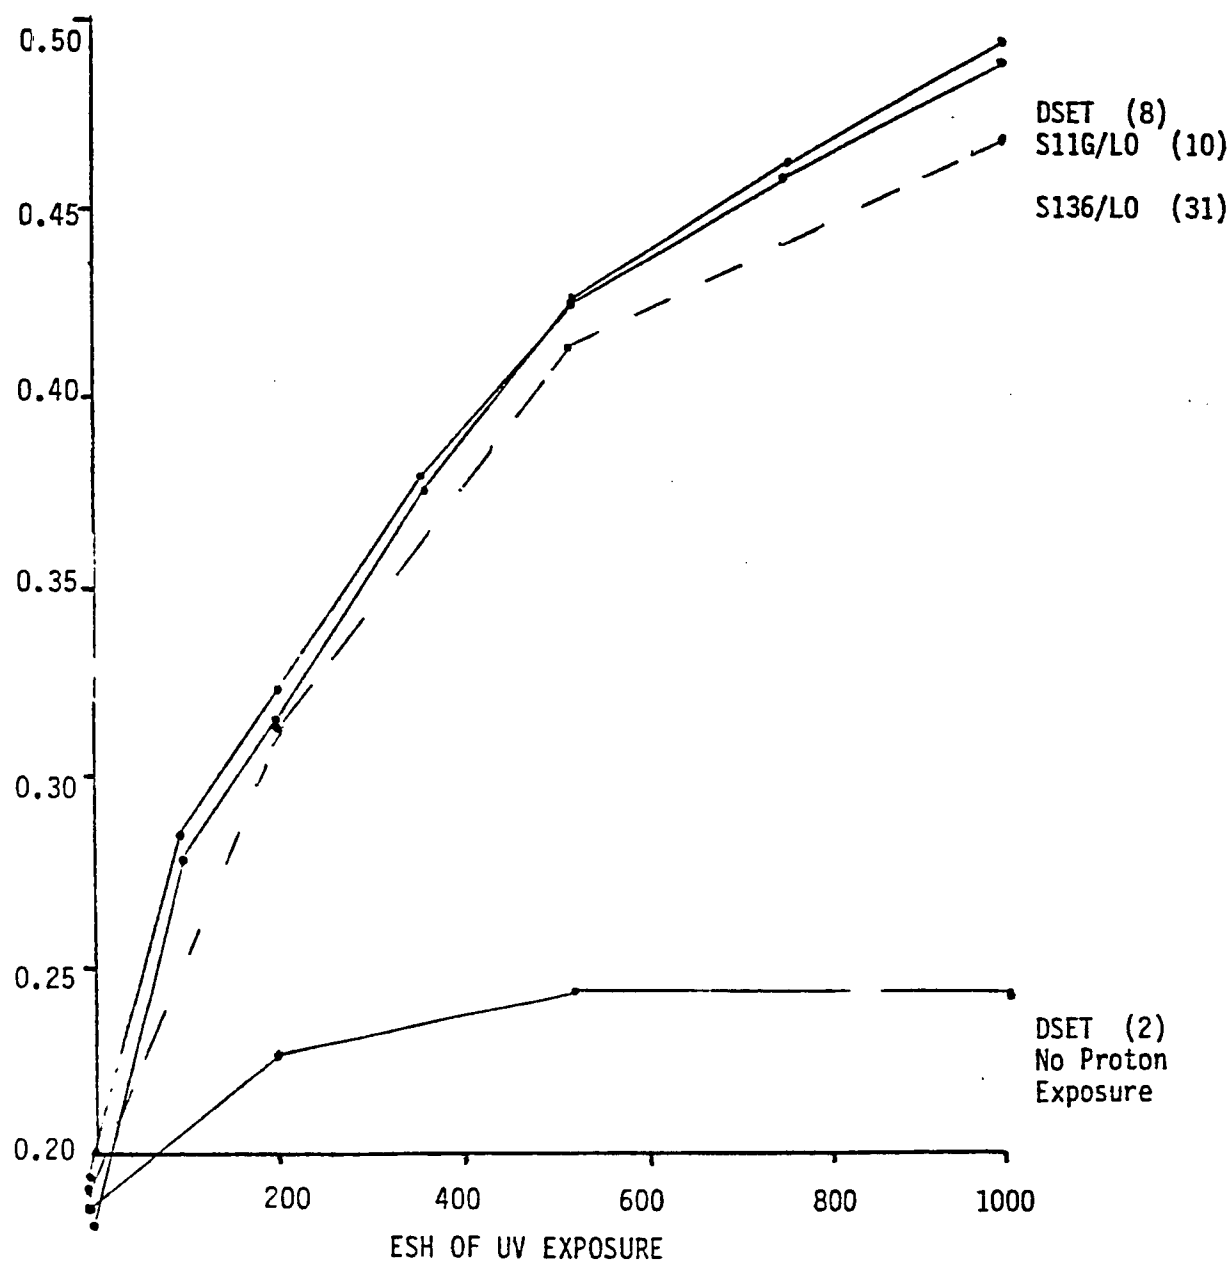
Figure 16: Changes In Absorptance Of White Pigmented Coatings As A Function Of Combined Proton, Electron, UV and VUV Exposure. Sample Locations Are In Parentheses. Sample At Location 31 Was Exposed To Slightly Reduced Levels Of All Radiation Types.

Changes in solar absorptance in the four white-paint samples were plotted in figure 16. The data suggest but do not conclusively demonstrate that Lyman-Alpha radiation may contribute to damage. The white paints were heavily

damaged by protons, especially in the visible wave length region that is important in determining alphas. This means variations in incremental proton and/or electron exposure levels (table 14) may effectively mask changes due to VUV.

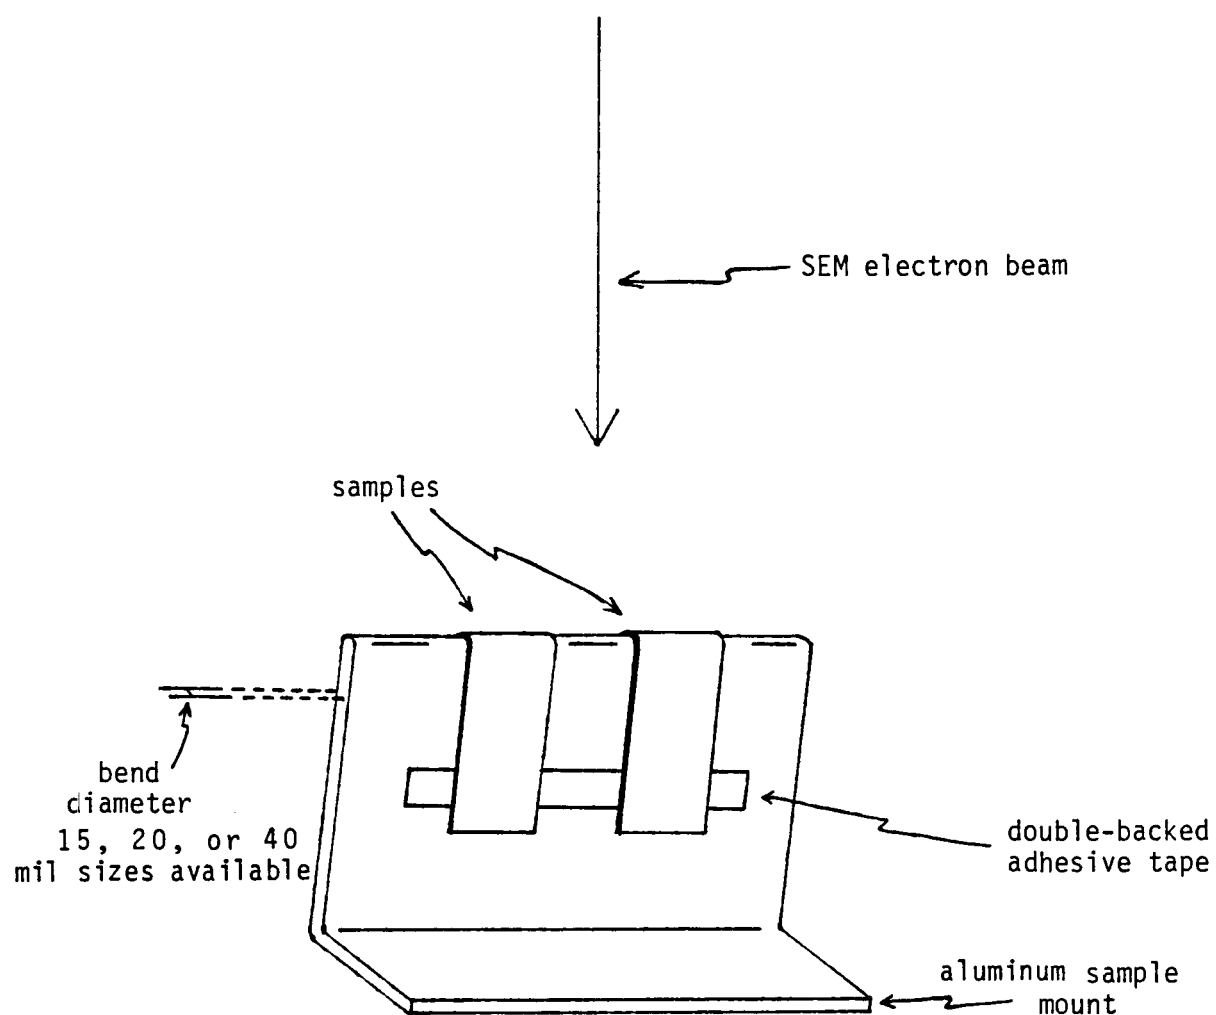
Figure 17: Bend Radius Test Sample Configuration

A strip of the material to be tested is bent over the rounded edge of the aluminum sheet chosen for the test. The material is then taped in place. The bend region is examined for evidence of cracking through the use of scanning electron microscopy (SEM). The orientation of the coating material relative to the SEM is sketched in figure 17. Results of this test is summarized in table 30.

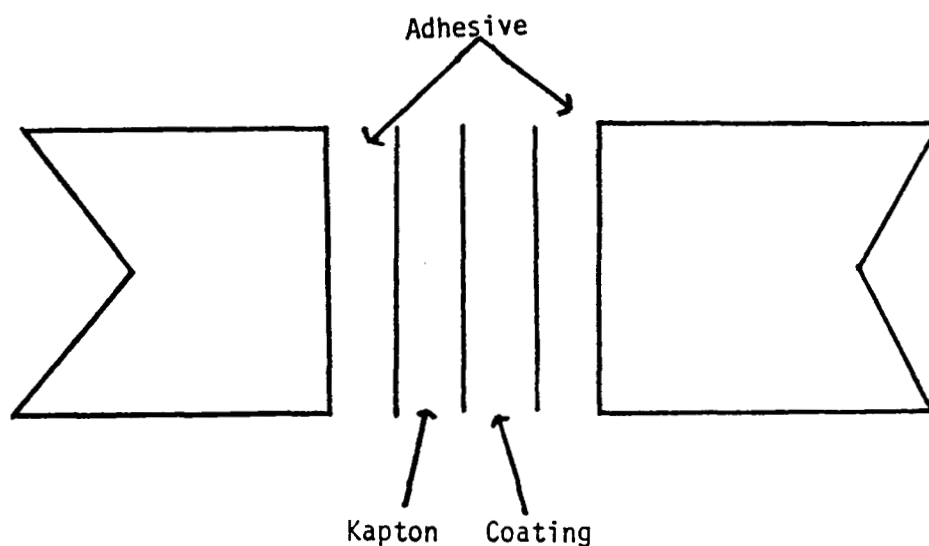
Figure 18: Flatwise Tension Test Sample Configuration

Kapton test samples coated on one side, were bonded with an adhesive between two blocks, (1 square inch, $\pm 1\%$). The test configuration is left until the adhesive has cured at room temperature and then any excess sample is trimmed. The test is then carried out using an Instron Tensile Tester. In each test, failure occurred between the adhesive and the Kapton. The test results indicate the adhesion between the Kapton and the coating material was greater than the adhesion between the Kapton and the adhesive holding the sample to the block. This test configuration is shown in figure 18.

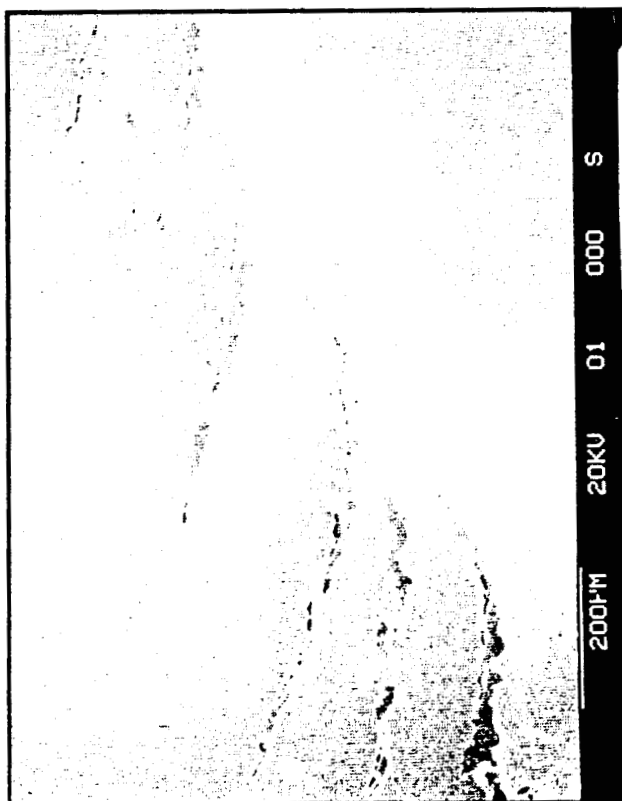
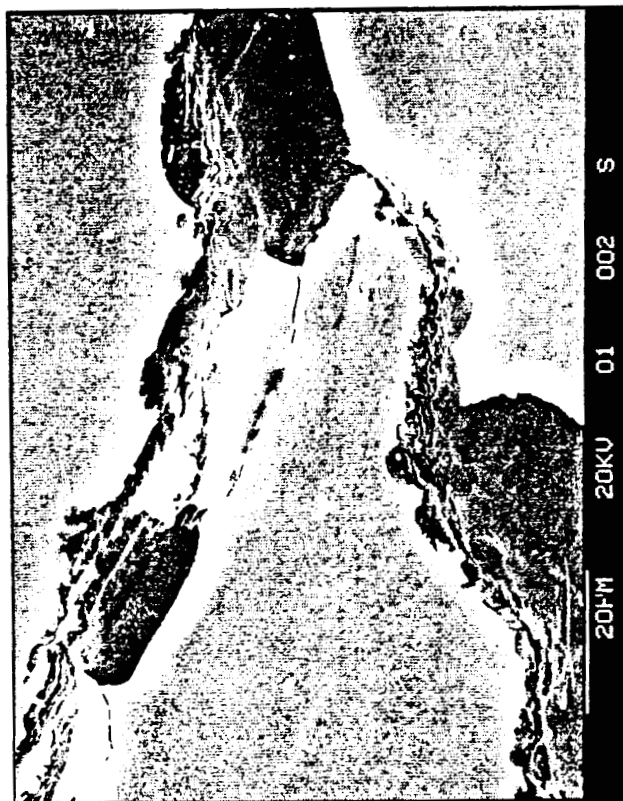
Figure 20: Results of Scanning Electron Microscopy of HMDS Coating
After Exposure to Combined Radiation Effects Test Environment

Specimens of coated Kapton which had been previously exposed to the combined radiation effects environment have been examined under a scanning electron microscope (SEM). Figures 19-24 show SEM photographs for these samples. Figure 19 shows SEM photographs of uncoated Kapton to allow comparison with the coated specimens. There are few surface features identifiable on the Kapton, and only at high resolution. Figure 20 shows the SEM photographs of hexamethyldisiloxane. This coating does exhibit some cracking and the higher resolution picture appears to show that small sections of the coating have flaked off. Figure 21 shows SEM photographs of S13 G/L0-1. This coating appears to have a granular, porous structure with some small cracks particularly visible in the higher resolution photograph. Figure 22 shows an SEM photograph of fluorophosphazene and of HMDS/TFE. The HMDS/TFE coating appears

to have flaked off in certain areas, much like the similar coating in figure 20. The fluorophosphazene coating has a textured appearance but few surface features otherwise. Figure 23 shows many cracks in the CV-1144 coating visible even at low resolution. Figure 24 shows a similar, but less extensive distribution of cracks for the CV-3530 coating.

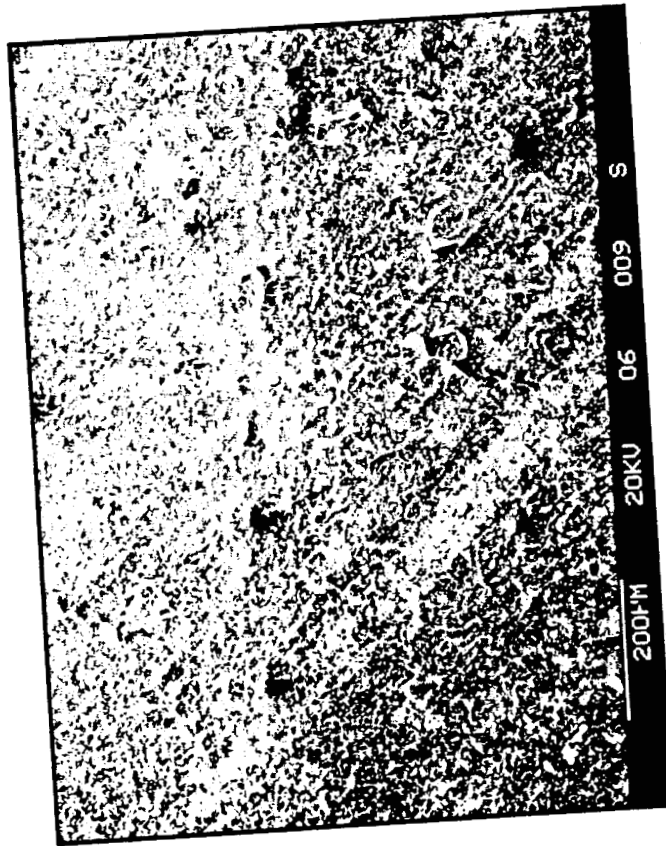
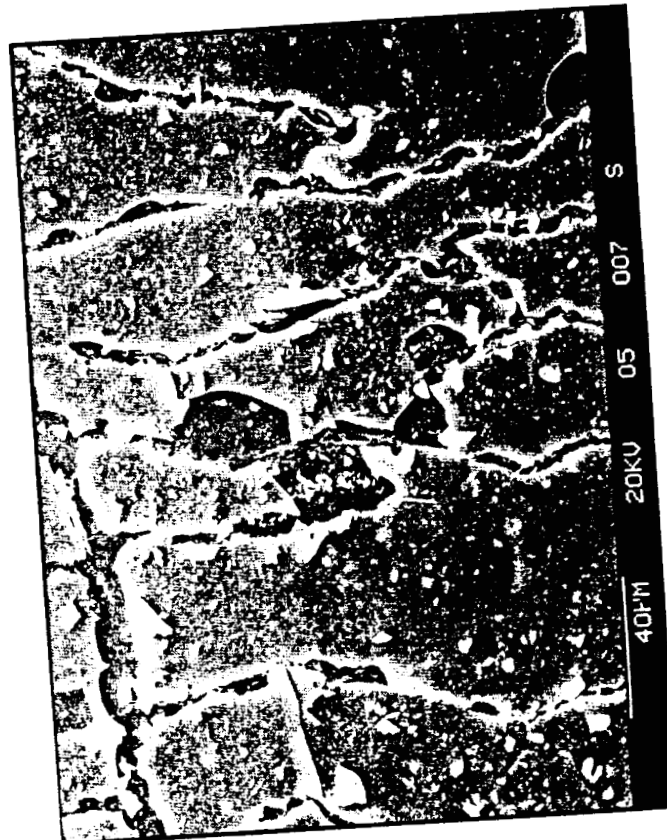
Figure 22: Results of Scanning Electron Microscopy of HMDS/TFE and
Fluorophosphazene Coatings After Exposure to Combined Radiation
Effects Test Environment

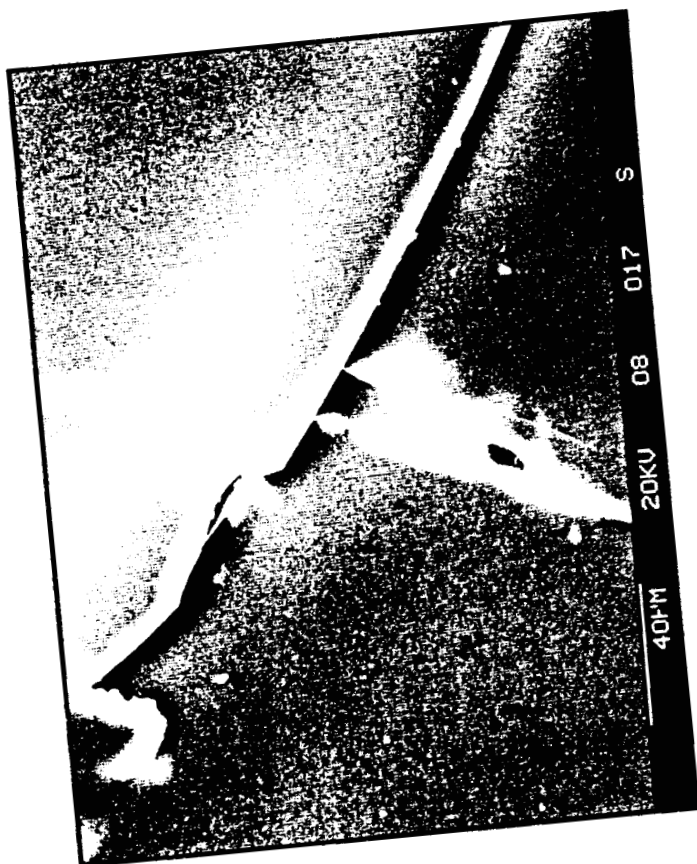
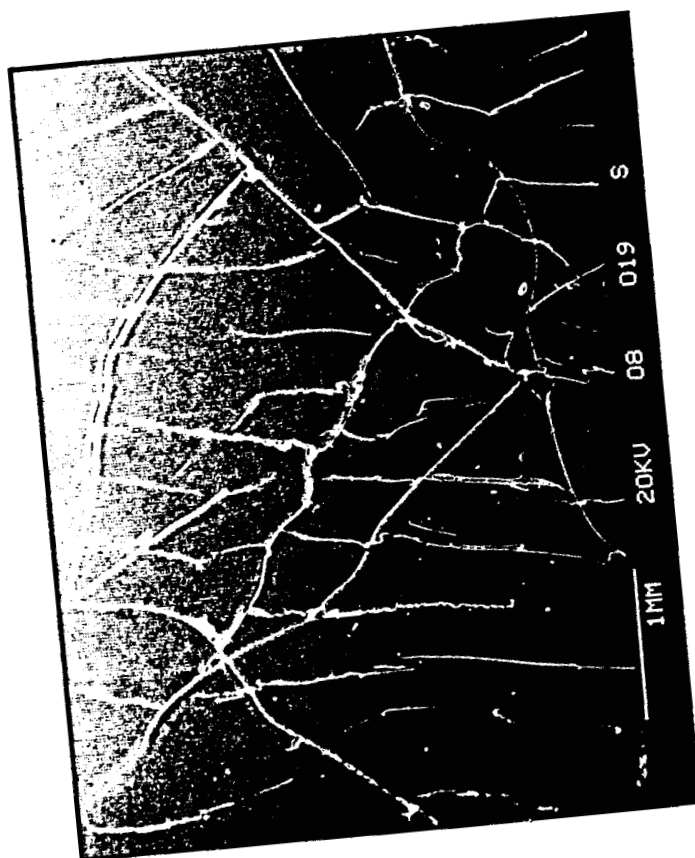
Figure 23: Results of Scanning Electron Microscopy of Silicone
(CV-1144) Coating After Exposure to Combined
Radiation Effects Test Environment

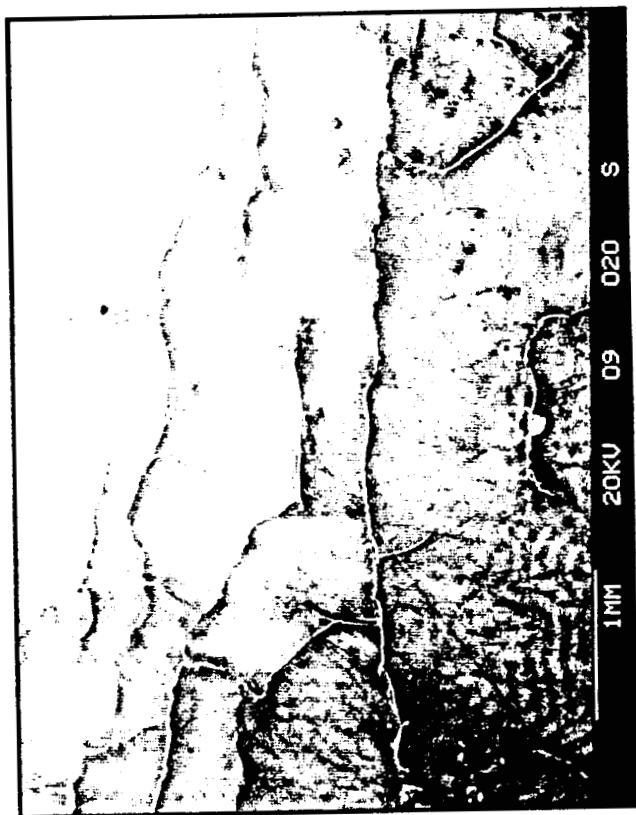
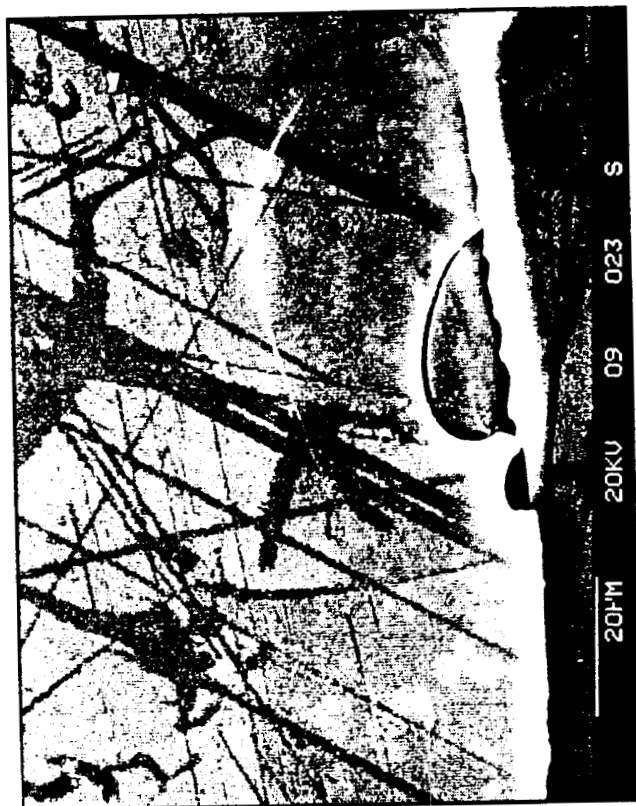
Figure 24: Results of Scanning Electron Microscopy of Fluorosilicone
(CV-3530) Coating After Exposure to Combined Radiation
Effects Test Environment

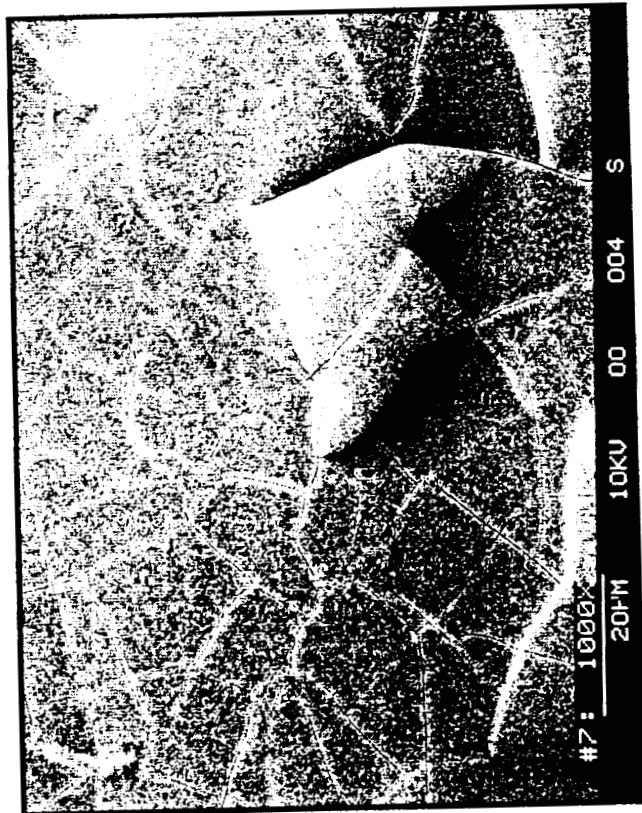
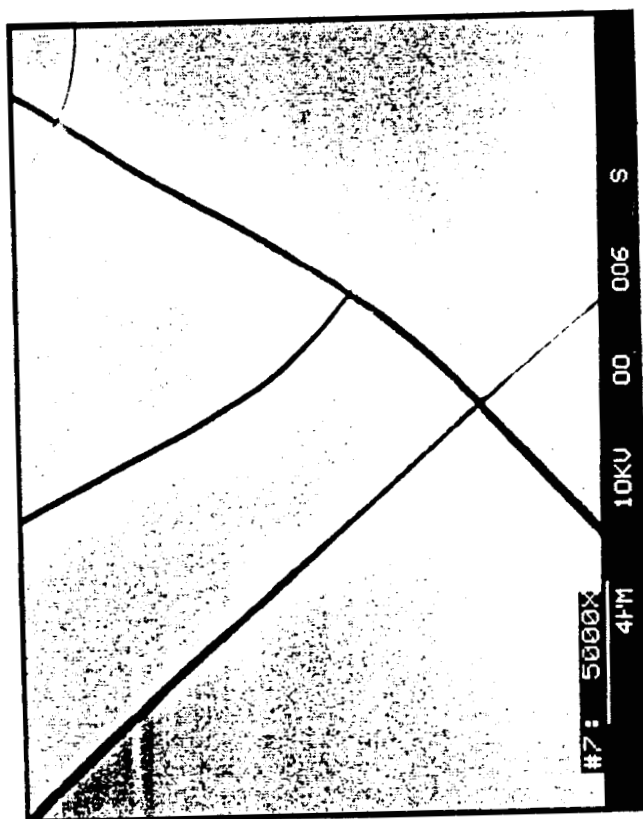
Figure 25: Results of Scanning Electron Microscopy on HMDS Coating.
The Sample was Previously Exposed to Atomic Oxygen for 25 Hours.

Figures 25-28 shows SEM photographs of materials which have been exposed to atomic oxygen. These photos show extensive cracking, areas where the coating has been removed, and indicate that oxygen atoms are undercutting the coatings. Thin, bright areas around the cracked areas indicate the possibility of attack by oxygen atoms at the adhesive bonds between the coatings and the Kapton substrate. Certain areas in figure 28 shows no coating remaining and the Kapton has a topography depending on the degree of exposure.

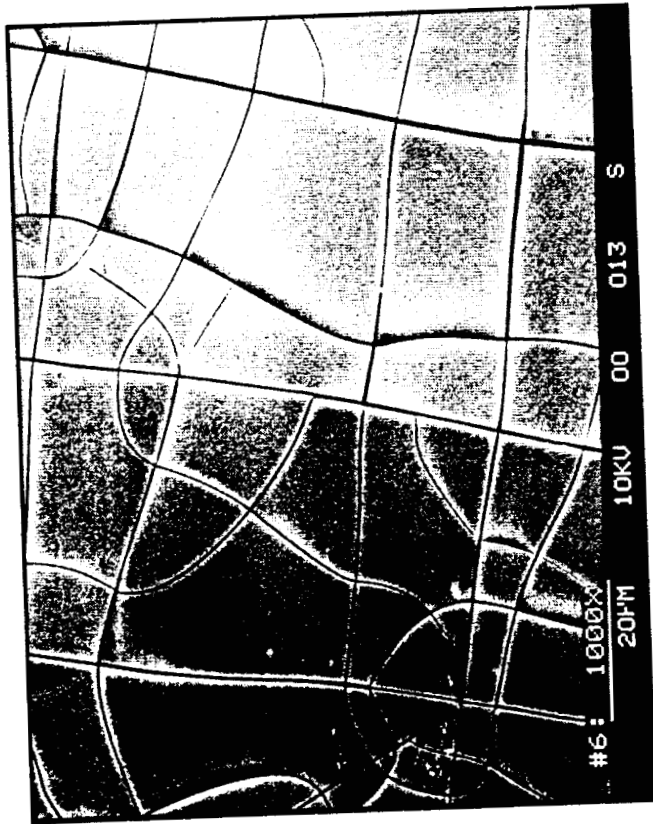
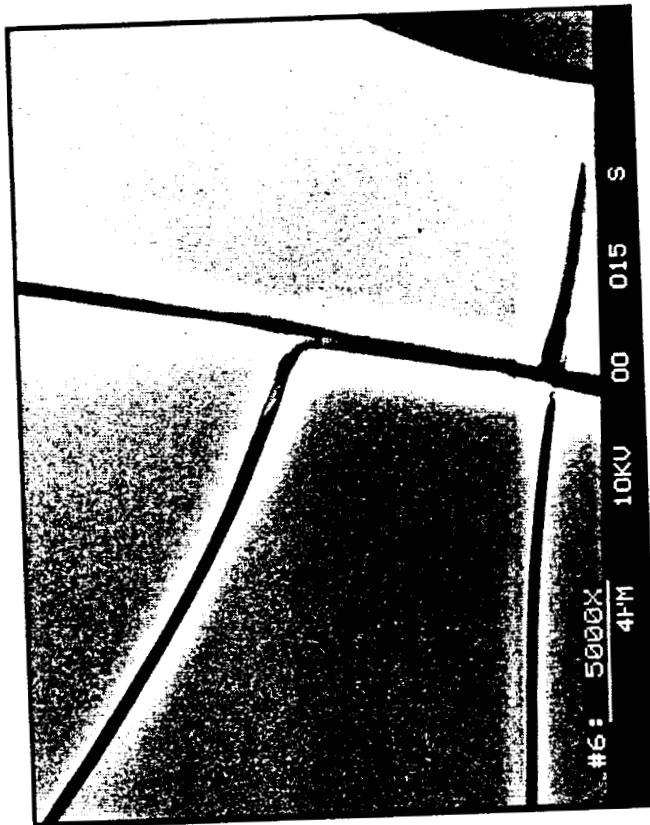
Figure 26: Results of Scanning Electron Microscopy on HMDS Coating.
The Sample was Previously Exposed to Atomic Oxygen for 48 Hours.

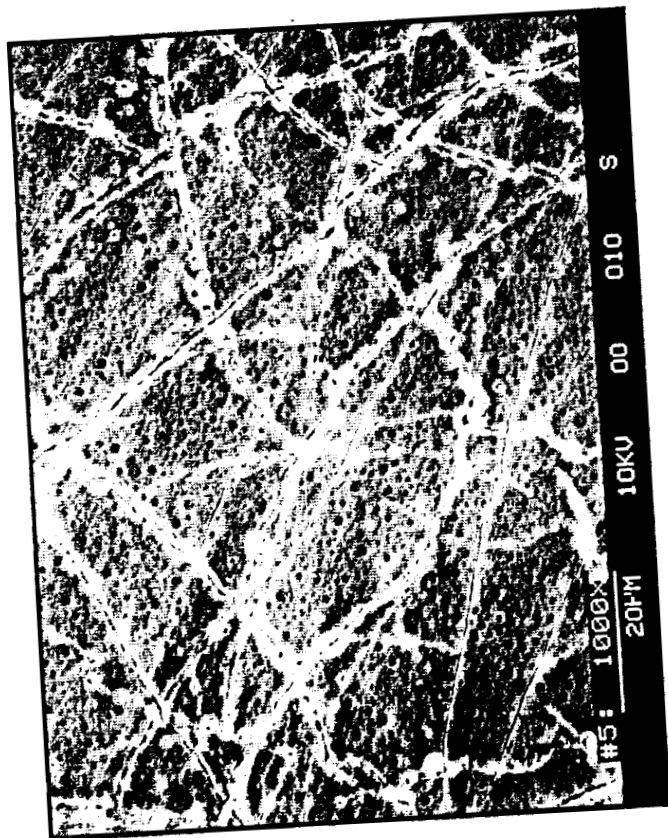
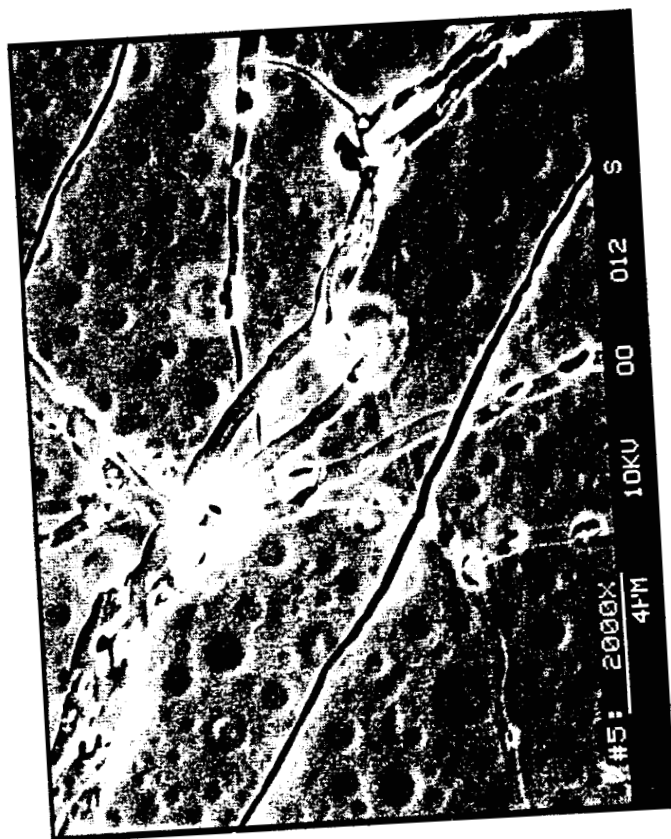
Figure 27: Results of Scanning Electron Microscopy on Polyimide-Siloxane Coating. The Sample was Previously Exposed to Atomic Oxygen for 93 Hours.

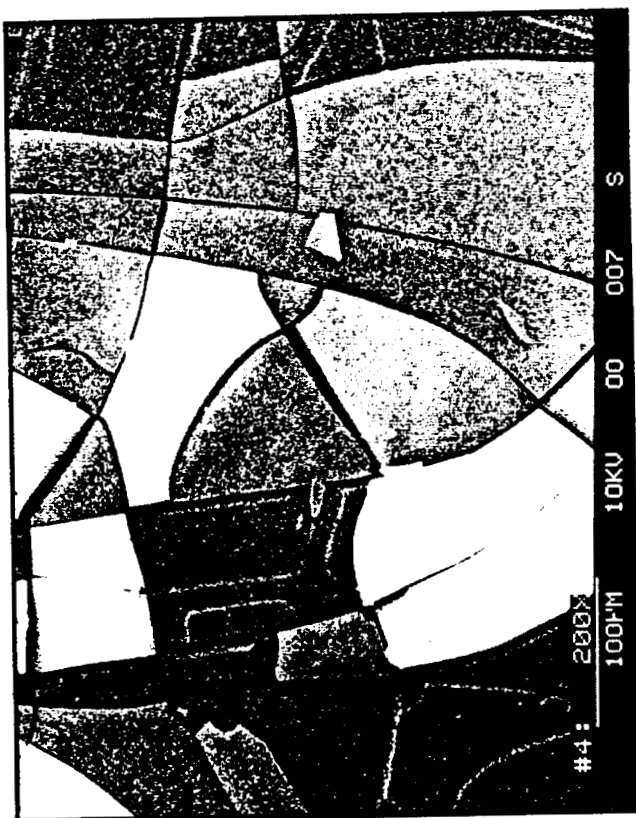
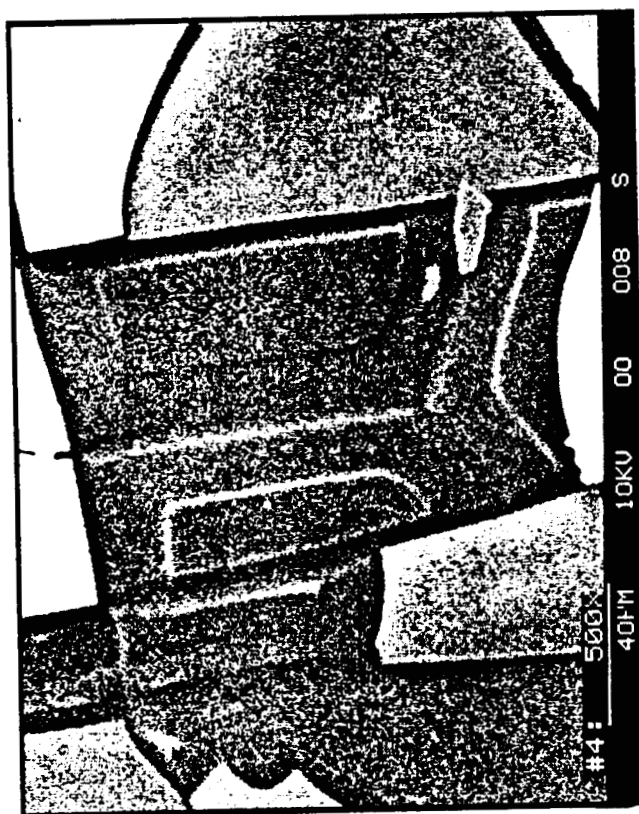
Figure 28: Results of Scanning Electron Microscopy on HMDS/TFE Coating.
The Sample was Previously Exposed to Atomic Oxygen for 96 Hours.

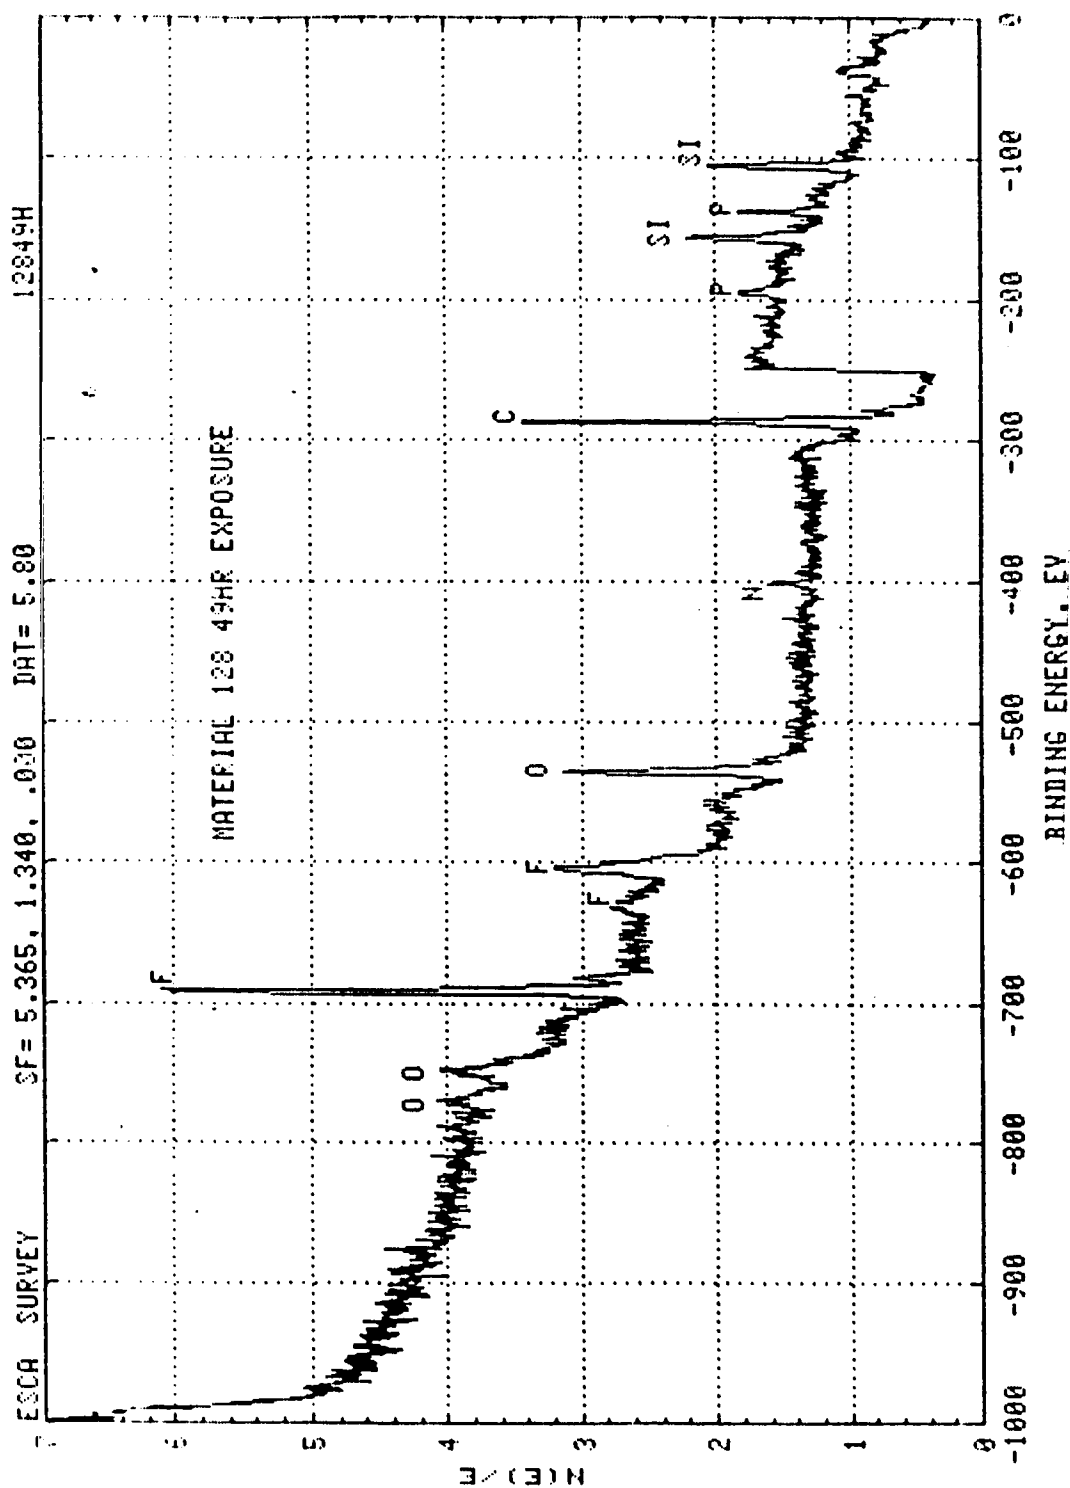
Figure 29: X-Ray Photoelectron Spectrum of Fluorophosphazene Coating on Kapton. The Sample was Previously Exposed to Atomic Oxygen for 49 Hours.

Figures 29 through 32 show X-ray photoelectron spectra of a fluorophosphazene, a siloxane-polyimide co-polymer after two different exposures, and a siloxane (CV-1144). Table 33 summarizes the surface elemental analysis for each specimen.

Figure 29 shows that the fluorophosphazene sample contains some silicon peaks, indicating cross-contamination from a siloxane sample being run simultaneously. Because of this evidence of cross-contamination, different material types should not be simultaneously exposed to atomic oxygen. Figures 30 and 31 show the siloxane-polyimide co-polymer after short and long term exposure to atomic oxygen (6 and 51 hours, respectively, December 87-January 88). The data in table 33 show the expected increase in oxygen and silicon relative to carbon. Figure 32 shows results of a repeat of earlier measurements on CV-1144 and shows the expected surface oxidation.

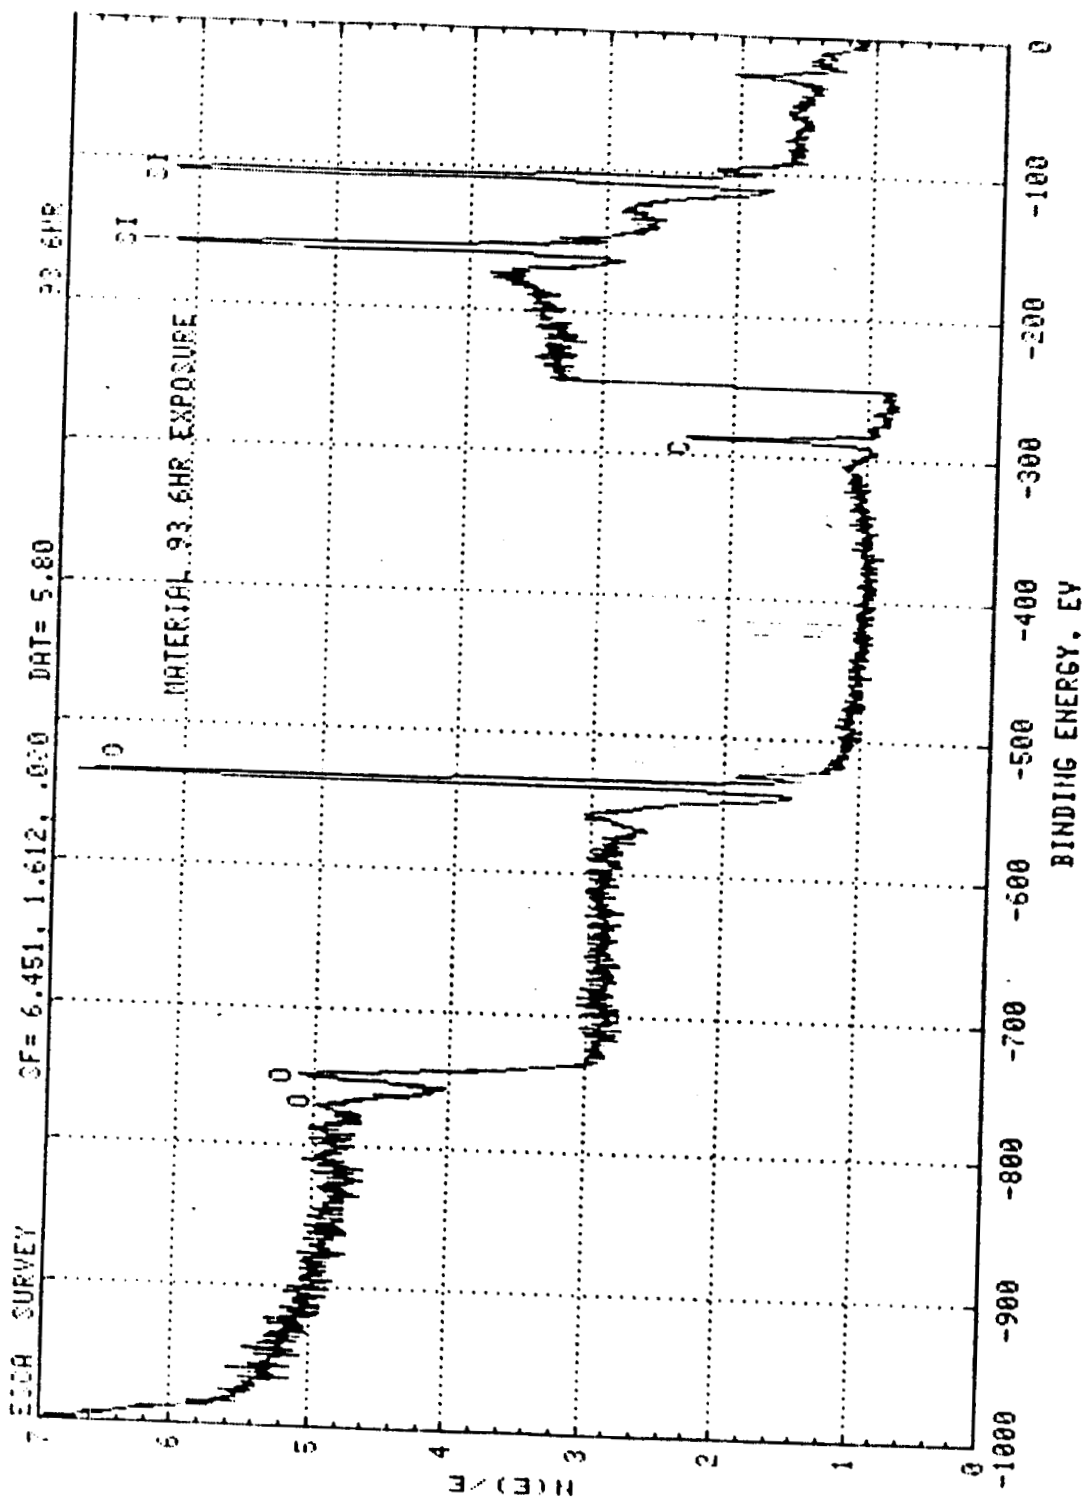
Figure 30: X-Ray Photoelectron Spectrum of Siloxane-Polyimide Co-Polymer Coating on Kapton. The Sample was Previously Exposed to Atomic Oxygen for 6 Hours.

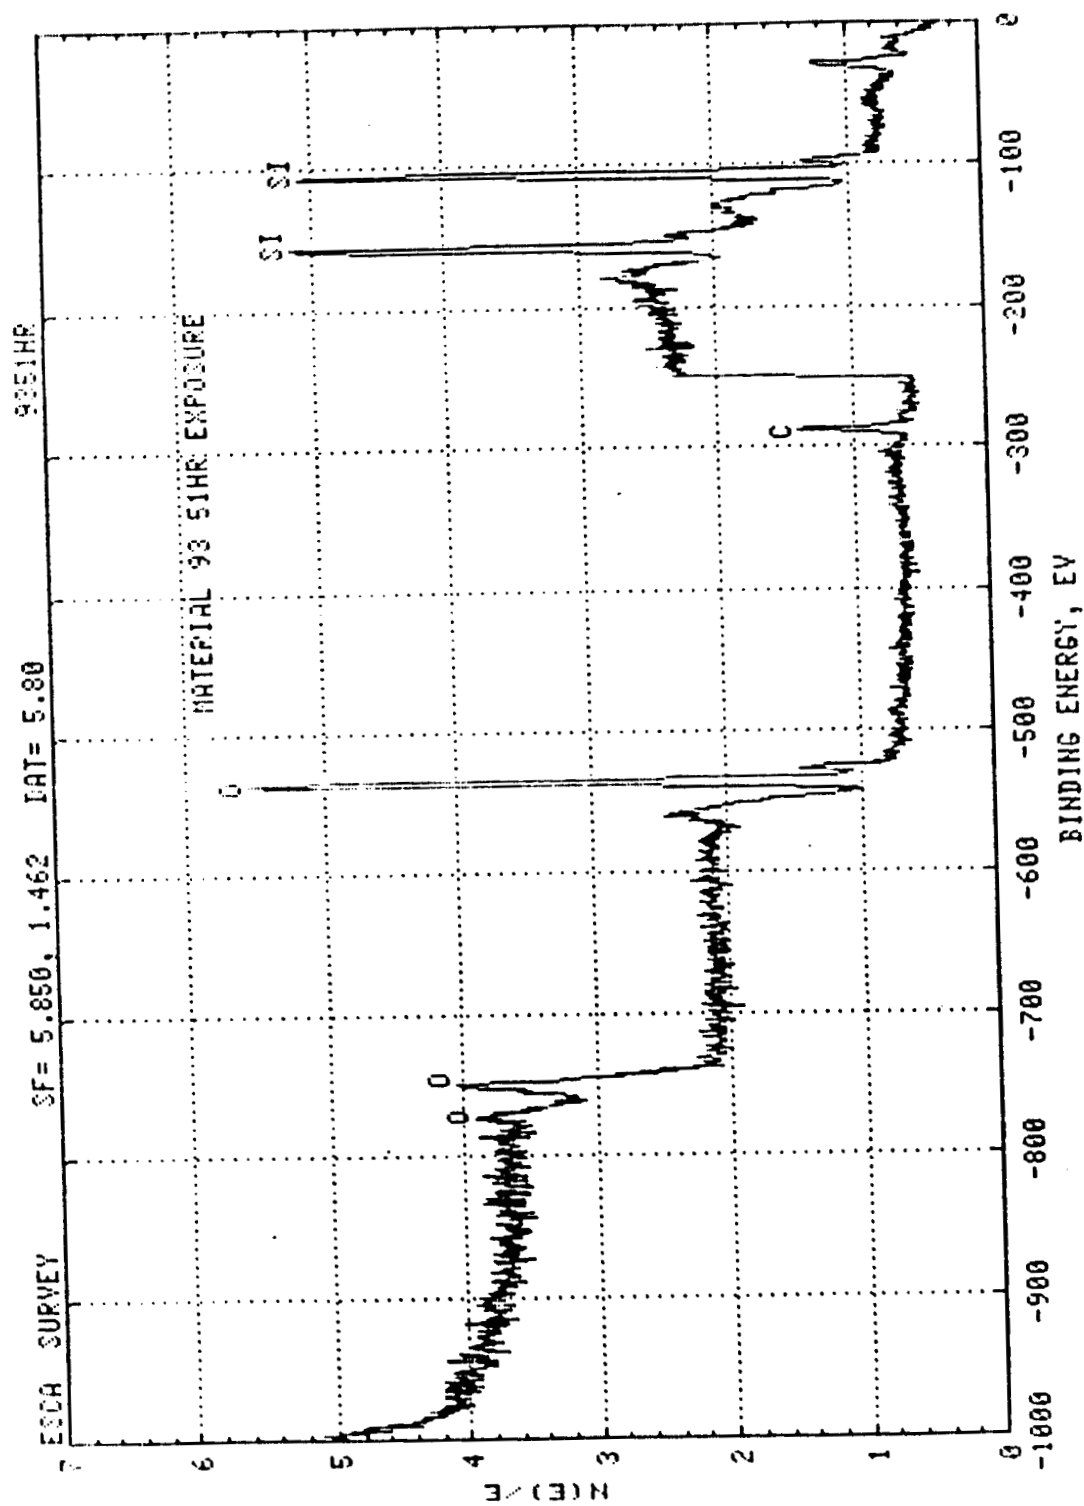
Figure 31: X-Ray Photoelectron Spectrum of Siloxane-Polyimide Co-Polymer Coating on Kapton. The Sample was Previously Exposed to Atomic Oxygen for 51 Hours.
